PICTORIAL ESSAY

Evaluation of ACL Graft by MRI: A Pictorial Review

DOI: 10.7191/jgr.2022.1151

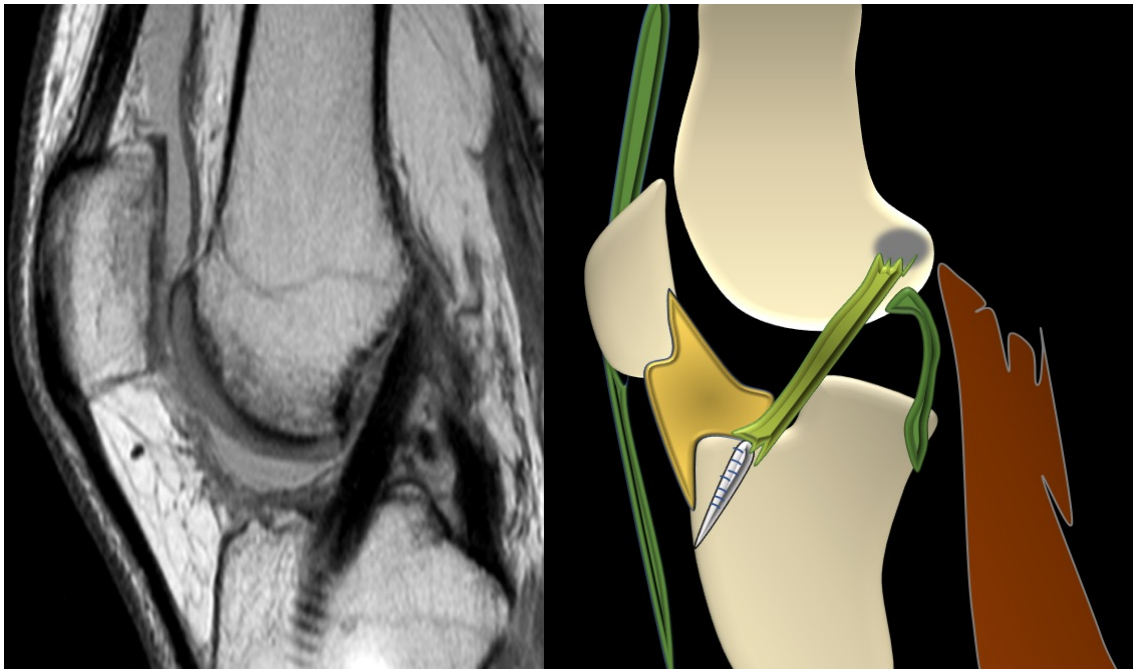
Figure 2. Sagittal T2W MRI of a 25-year-old male patient three years post ACL reconstruction showing the normal-appearing homogeneously hypointense ACL graft.

ACL grafts appear in MR images at a uniformly low signal intensity, similar to the signal characteristics of the native graft harvest tissue (patellar tendon or hamstring tendon) [Figure 2]. Increased intrasubstance graft signal changes develop within the first year after surgery and are thought to represent changes related to synovial proliferation, vascularisation, and “neoligamentization” of graft constructs. Complete resolution of such graft signal changes are often described 18–24 months after surgery [3]. Due to ongoing ligamentization of the graft for up to one and a half years, postoperative ligament evaluation MRI may be warranted in patients experiencing severe discomfort or reinjury [11].

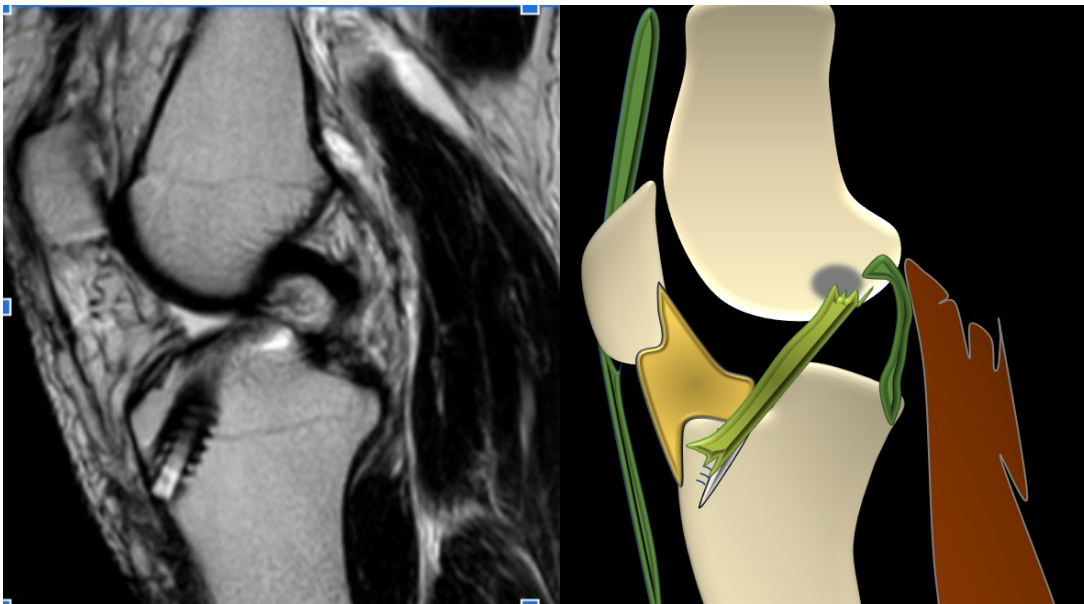
Figure 6. A 30-year-old man who presented for follow-up imaging six years after ACL reconstruction showing a too-anteriorly placed tibial tunnel.

Anteriorly placed tibial tunnel: If the tibial tunnel is positioned too far anteriorly (i.e., partially or completely anterior to the intersection of the Blumensaat line), the graft can become impinged on by the roof of the intercondylar notch, which can lead to decreased range of motion [Figure 6,7].

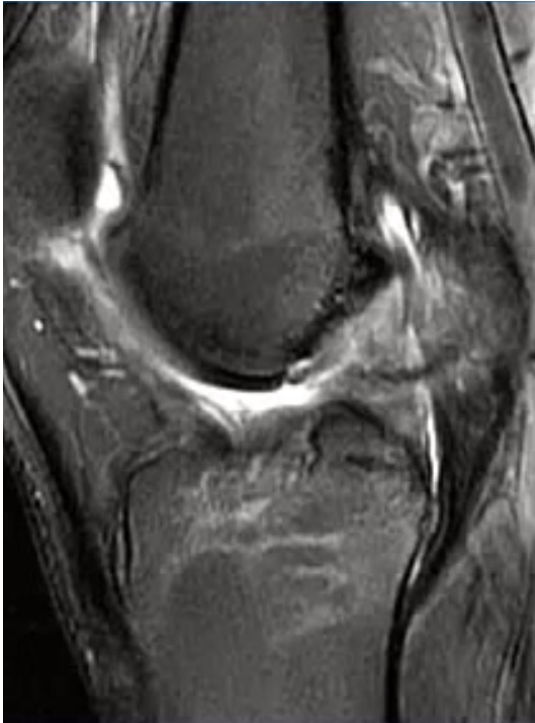
Figure 8. Graft tear in 21-year-old man who presented for follow-up imaging after ACL reconstruction. Sagittal proton density weighted MRI shows complete tear of the ACL graft.

Grafts are most susceptible to injury during the process of remodelling, which occurs approximately four to eight months after surgery. The primary signs include graft signal abnormalities including increased signal on T2-weighted sequences, increased graft thickness, and fiber discontinuity [13] [Figures 8,9].

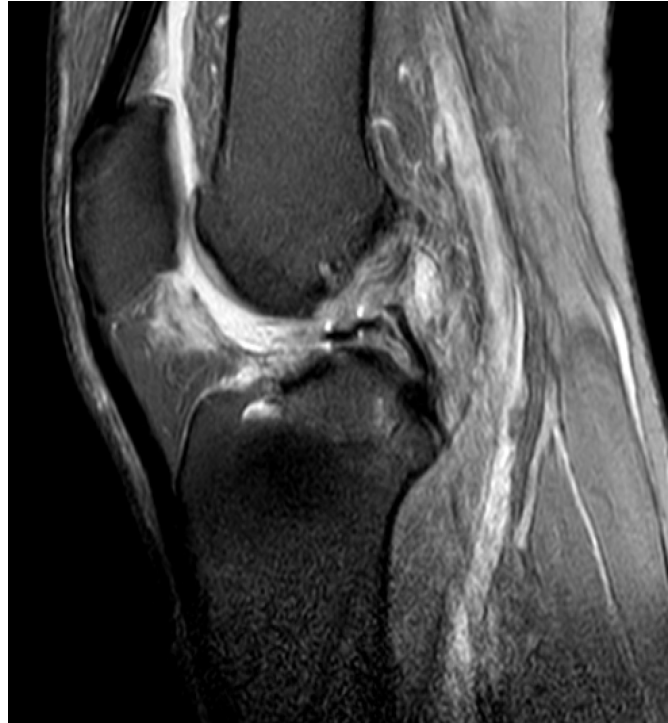
Figure 9. Partial graft tear in 21-year-old man who presented for follow-up imaging after ACL reconstruction. Sagittal proton density weighted MRI shows partial tear of the ACL graft with graft laxity.

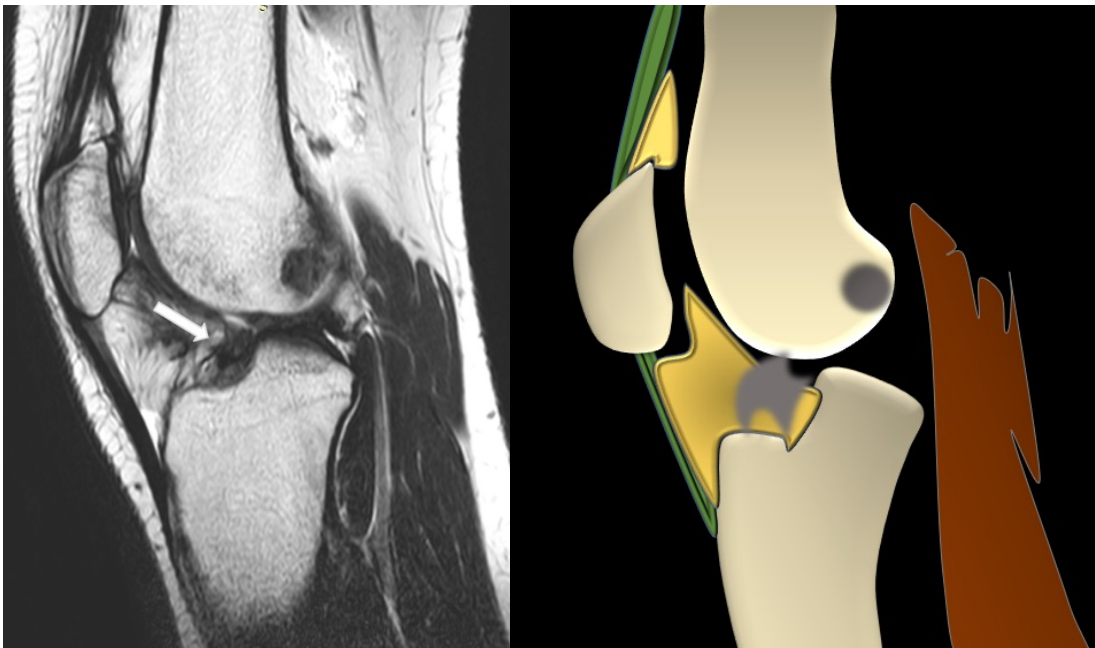
Figure 10. T2W sagittal MRI shows localized/focal arthrofibrosis.

Arthrofibrosis: Two forms of arthrofibrosis are possible in the form of limitation of flexion [8] [Figures 10-12]. In MRI, both forms show low signal intensity on T1-weighted sequences and are predominantly low signal on T2-weighted sequences. Arthrofibrosis may be focal or diffuse. The focal form is seen as a nodule of low signal (a cyclops lesion) just anterior to the distal end of the graft between

the femur and tibia. The diffuse form seen as an ill-defined spiculated area of low signal within the Hoffa fat pad or a mass-like area of decreased signal anterior and posterior to the graft. This can extend to the joint capsule with possible synovial hypertrophy and capsular thickening [1,4].

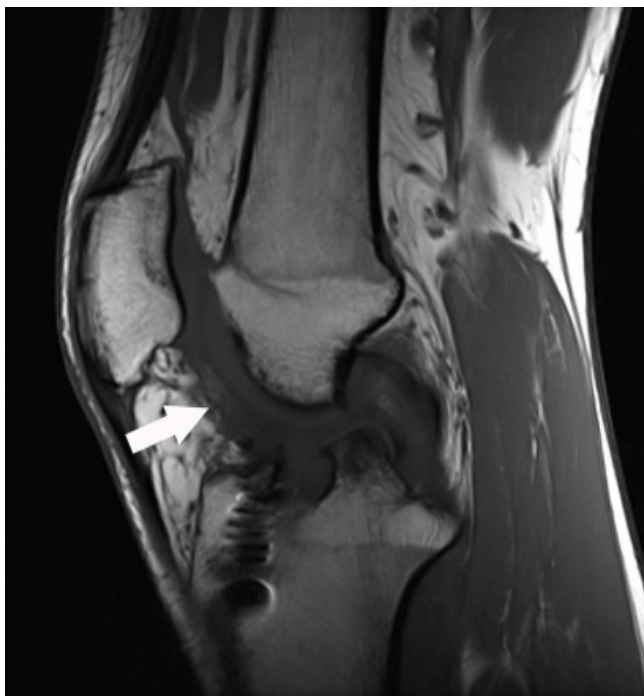
Figure 12. T1W sagittal MRI showing diffuse arthrofibrosis, extending up to hoffas fat pad.

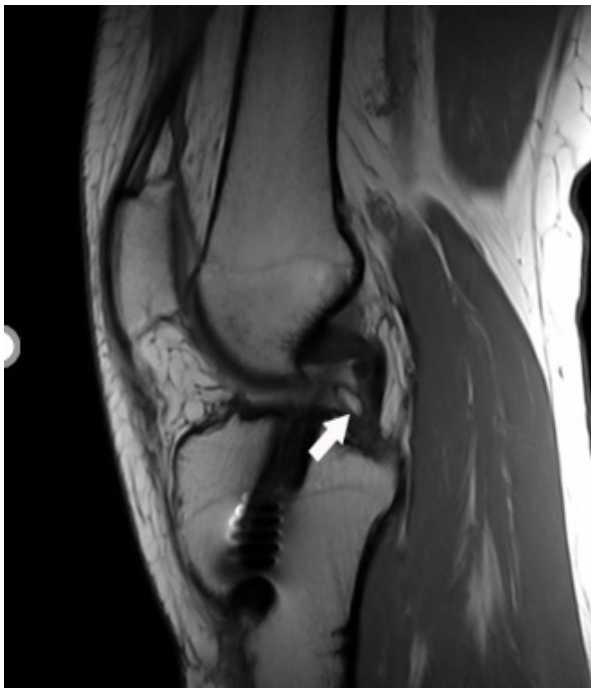
Figure 15. Sagittal T1W MRI of a 32-year-old man following post ACL reconstruction showing a displaced bone plug.

Hardware failure is uncommon but is important to recognize because it can cause instability of the graft which can be confused with graft disruption. Hardware failure includes screw displacement and dislodgment of the bone plug [2].

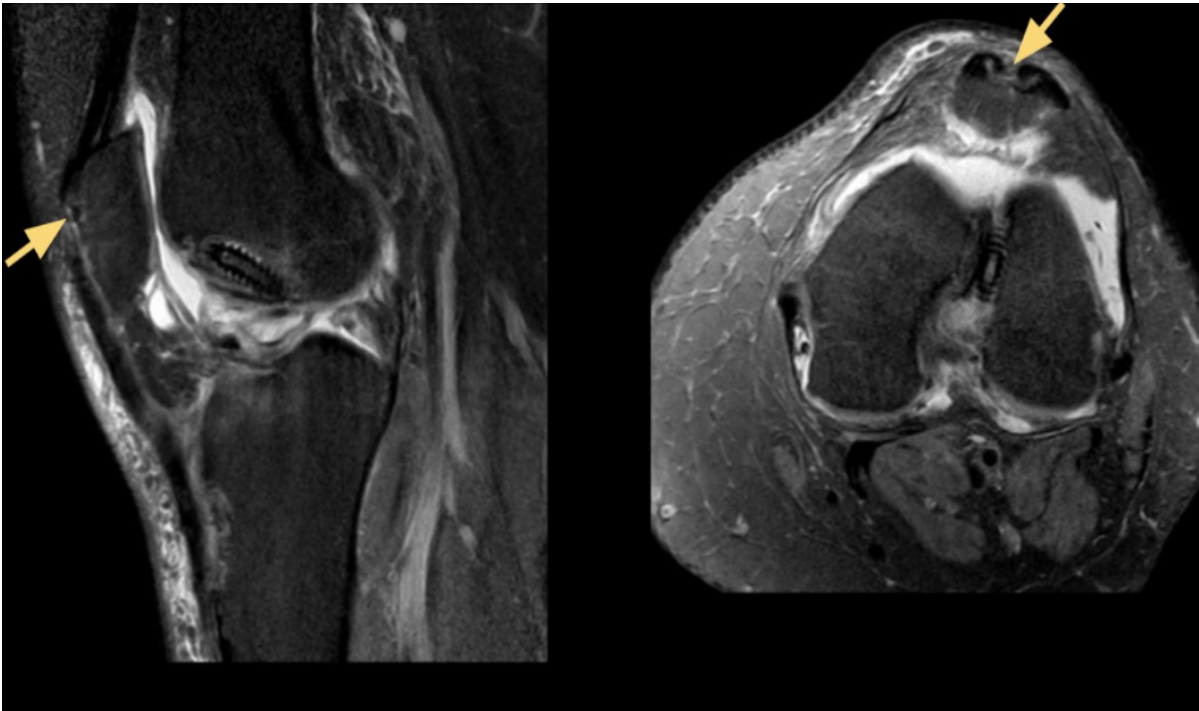
Figure 16. Sagittal and axial proton-density-weighted MR image shows signal heterogeneity of the patellar tendon at the graft harvesting site.

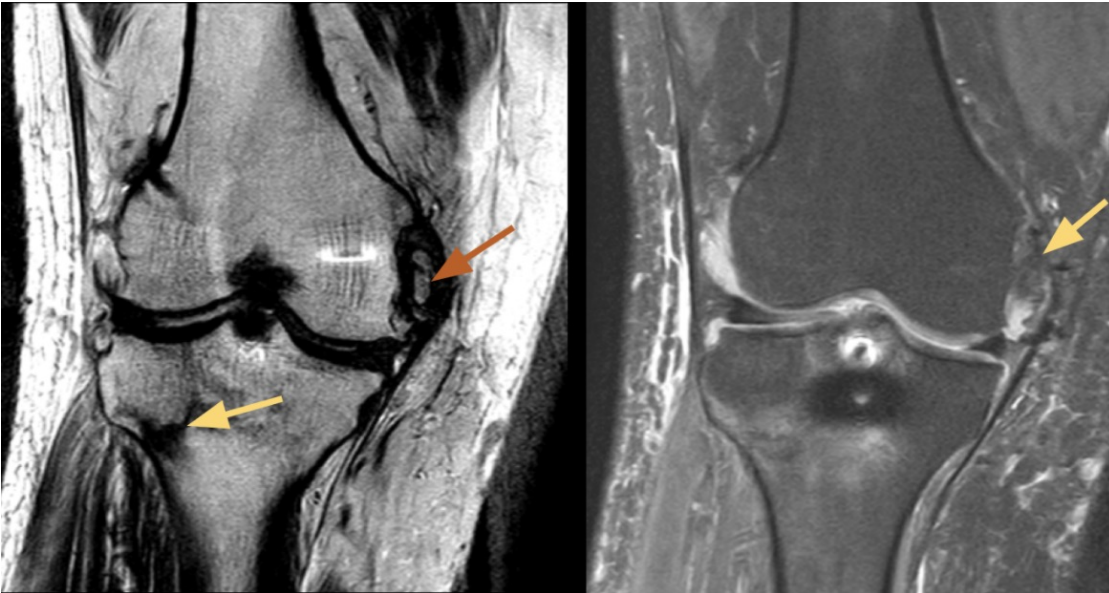
Figure 18: A 36-year-old male presented with re-trauma after ACL reconstruction coronal T2W and PDW images show tibial fracture and malunited medial femoral condyle fracture (Steida fracture).

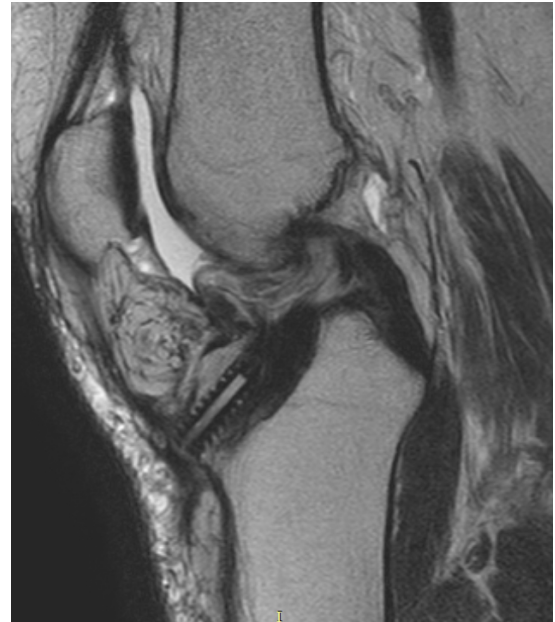
Figure 21. Sagittal PDW MRI showing displaced tibial screw in a 25-year-old patient.
